# Microstructural investigations of Ni and Ni<sub>2</sub>Al<sub>3</sub> coatings exposed in biomass power plants

The present work investigates the corrosion resistance of Ni and Ni<sub>2</sub>Al<sub>3</sub> coated austenitic stainless steel (TP347H) tubes, which were exposed in a biomass-fired boiler with an outlet steam temperature of 540°C for 6757 h. The Ni<sub>2</sub>Al<sub>3</sub> coating was produced by electroplating Ni followed by low temperature pack cementation. After exposure, microstructural investigations were performed by light optical and electron microscopy (SEM-EDS). Electroplated Ni coatings were not protective in straw firing power plants and exhibited similar corrosion morphology as uncoated tubes. For Ni<sub>2</sub>Al<sub>3</sub> coatings, the nickel aluminide layer was no longer adherent to the tube and was only found within the deposit. However, Ni<sub>2</sub>Al<sub>3</sub> coatings had provided some protection compared to uncoated and Ni coated tubes. The formation of nickel chloride binds aggressive chlorine and slows down the active oxidation mechanism. In local areas, sulphidation corrosion attack of Ni was detected.

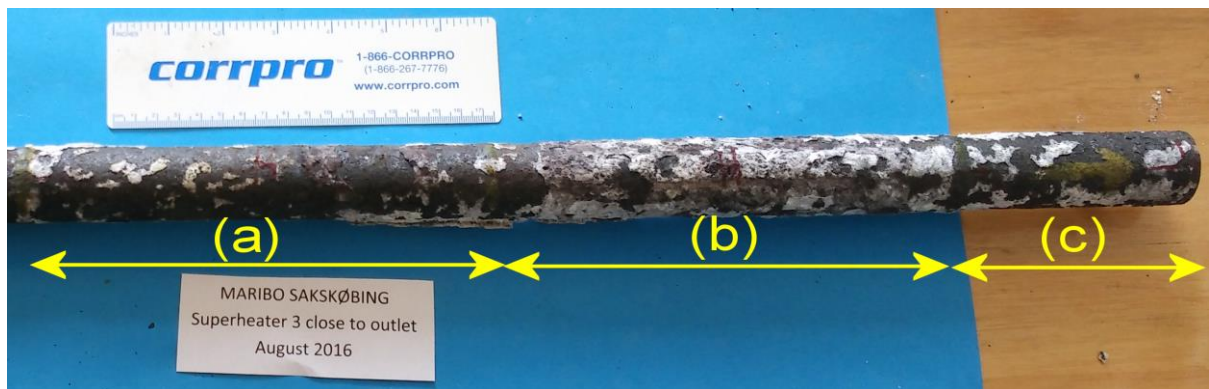
The exposed tubes after removal from the power plant are shown in Figure 2. Prior to removal of the tubes, the superheater had to be cleaned and this resulted in removal of deposit and some of the surface corrosion products. The  $\text{Ni}_2\text{Al}_3$  coated tube was covered with a thick layer of corrosion product together with deposit in most areas. Some of the corrosion product and deposit was scraped off the tube and prepared for analysis. Lesser amounts of deposit were present for the Ni coated tube and uncoated tube.

Figure 2. Morphology of (a) Ni coated, (b)  $\text{Ni}_2\text{Al}_3$  coated and (c) uncoated tubes after boiler exposure

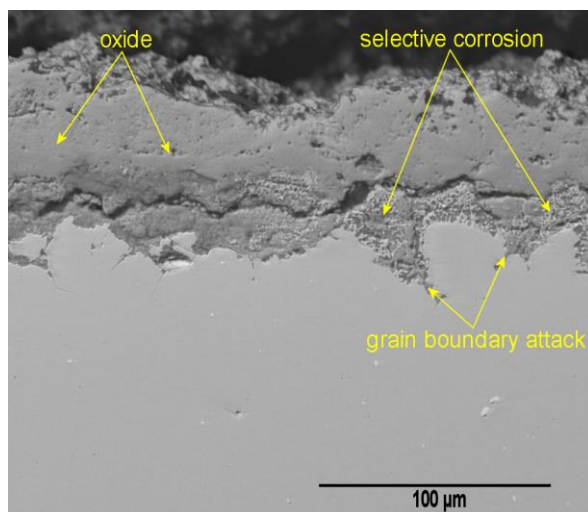
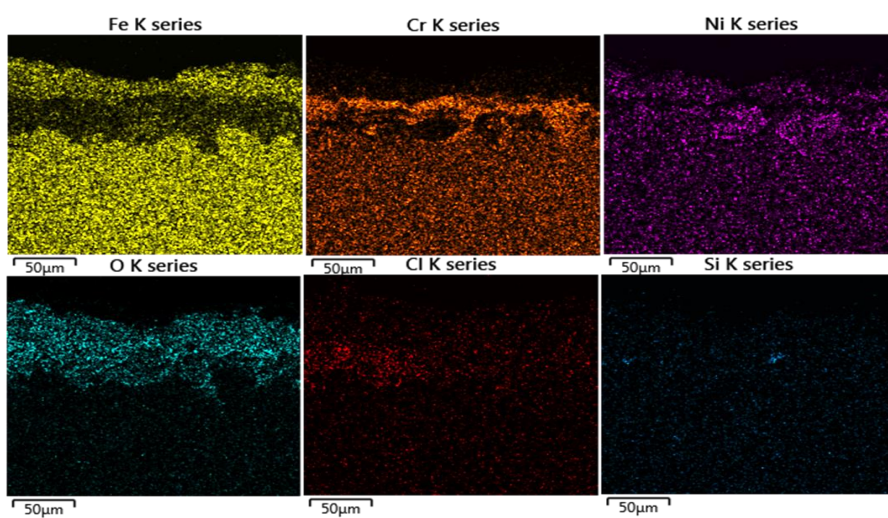
Different corrosion morphologies were evident on the exposed uncoated tube. In some areas, an oxide layer was present with limited underlying grain boundary attack (Figure 4), while deep grain boundary attack was observed in other areas (Figure 5). The corrosion product consisted of an outer oxide, an inner selective corrosion area and grain boundary attack. The oxide located in the outermost corrosion product was rich in iron, and the oxide below was rich in chromium. There was selective corrosion attack beneath the oxide, and chromium depletion was detected together with nickel enrichment (EDX results in Figure 4). Enrichment of chlorine was identified close to the corrosion front in the selective corrosion area. The indications of silicon enrichment close to the selective corrosion area were probably due to use of SiC papers in the grinding process.

Figure 4. SEM/BSE image of the corrosion morphology and EDX chemical element distribution for the uncoated tube after boiler exposure

According to the element distribution in Figure 4, potassium was not present at the corrosion front. Thus, Cl species must have been released, which could be due to reactions between KCl and metal oxides or sulphation of KCl.  $Cl^-$  ions could also be generated by reaction of HCl and oxygen [13] or via reaction 1.

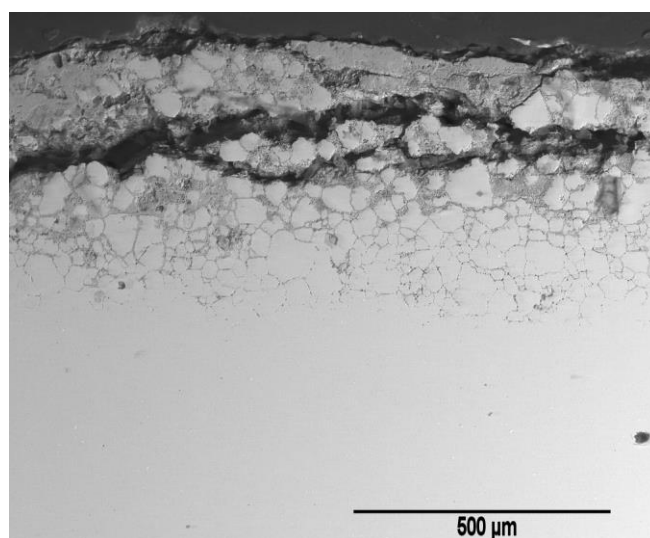
Figure 5. SEM/BSE image of corrosion morphology showing deep grain boundary attack in the uncoated tube after boiler exposure.

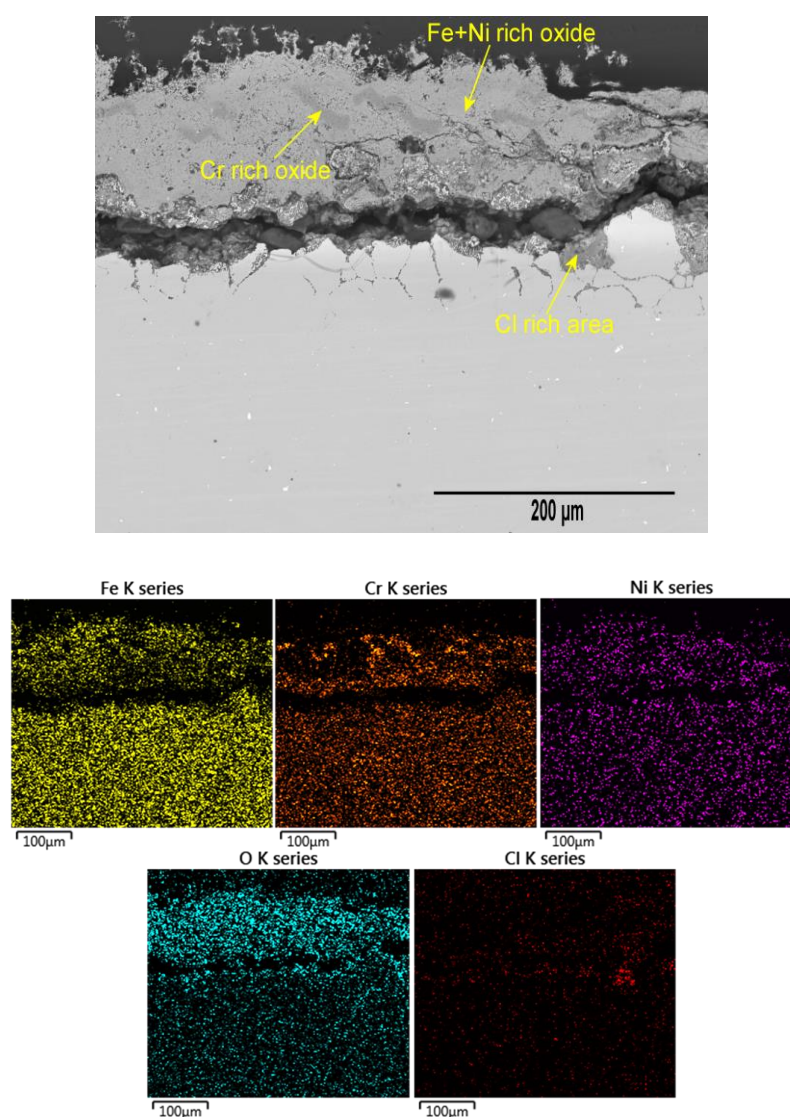
The morphology of corrosion products and chemical element distribution are given in Figure 6. The pure Ni layer was no longer present on the Ni coated tube after exposure. A voluminous corrosion product was formed at the outermost surface. The corrosion products were rich in iron and nickel in the outer part and rich in chromium in the inner part. Clear enrichment of chlorine was observed close to the underlying metal.

Figure 6. SEM/BSE image of corrosion morphology and EDX chemical element distribution for Ni coated tube after boiler exposure

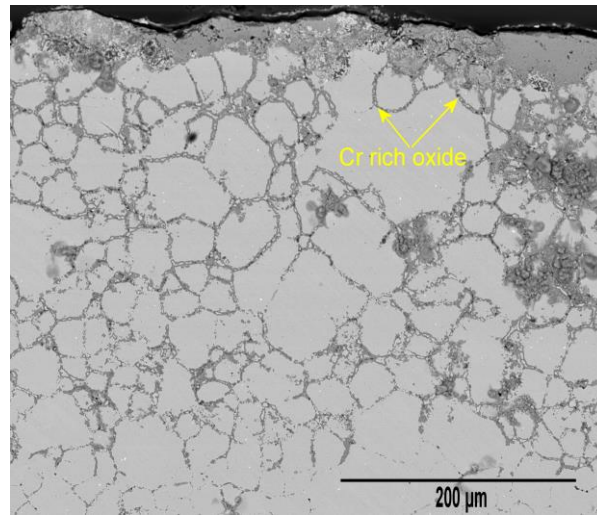
Localised grain boundary attack could be seen in locations with voluminous outer oxide, while deeper grain boundary attack was apparent in areas with thinner corrosion products (Figure 7), similar to the findings for the uncoated tube. Since the KCl was not revealed on cross-sections, some surface oxide could have spalled during tube removal and handling.

Figure 7. SEM/BSE image of a location with severe grain boundary attack for Ni coated tube after boiler exposure

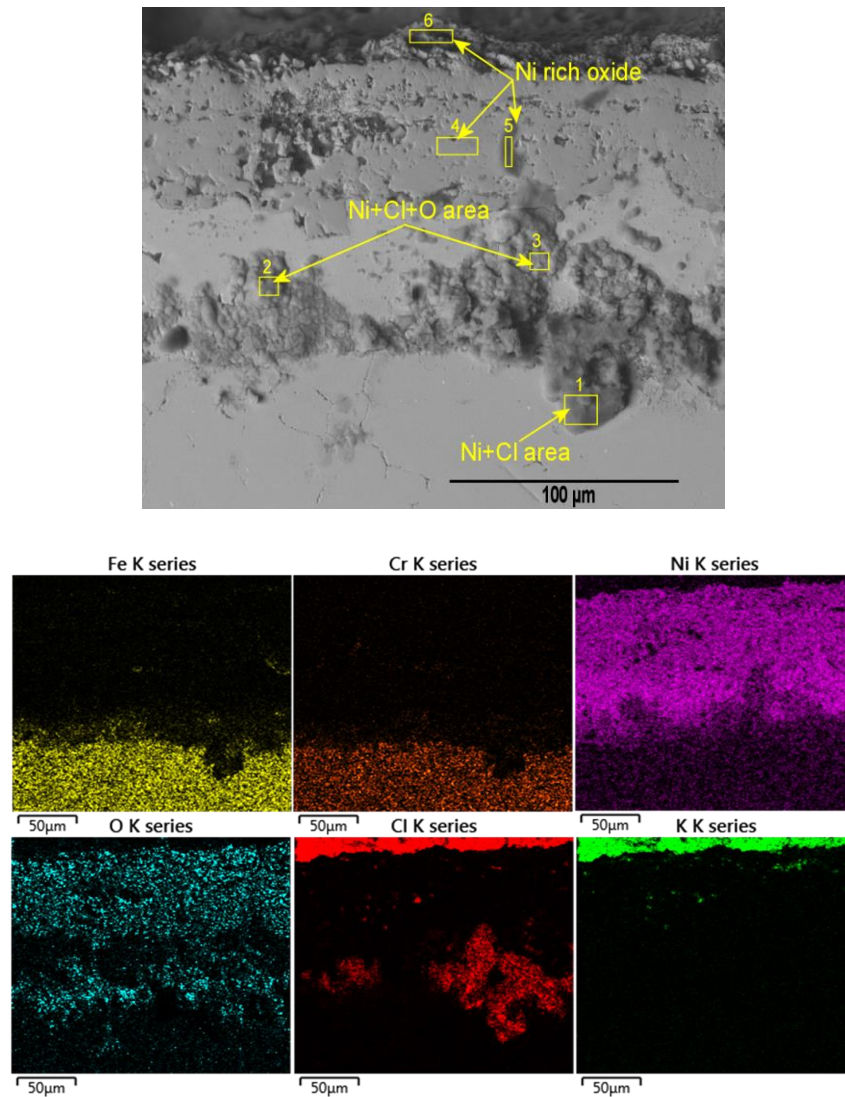
Figure 8. SEM/BSE image of corrosion morphology and element distribution on the  $\text{Ni}_2\text{Al}_3$  coated tube after boiler exposure at a location where the Ni layer was present. In the SEM image, location of EDX measurements was reported in Table 2.

SEM-EDS analysis shows that the external oxides are rich in nickel only (Table 2). A large area with chlorine enrichment could be identified below the nickel enriched outer oxide. Above the nickel coating-TP347H interface, the chlorine species are associated with nickel (region 2 and 3), however within the TP347H layer, the Cl species are associated with Ni, Fe and Cr (region 1). The morphology of the Cl species seems to indicate that they have emerged from the metallic material after polishing and that they

Elemental composition (wt. %)					
region	Cl	Ni	O	Fe	Cr
1	35.1	24.5		35.0	5.4
2	26.7	40.1	24.0	8.9	0.4
3	30.5	47.0	18.7	3.8	
4		84.6	15.4		
5		79.4	20.6		
6		84.8	15.2

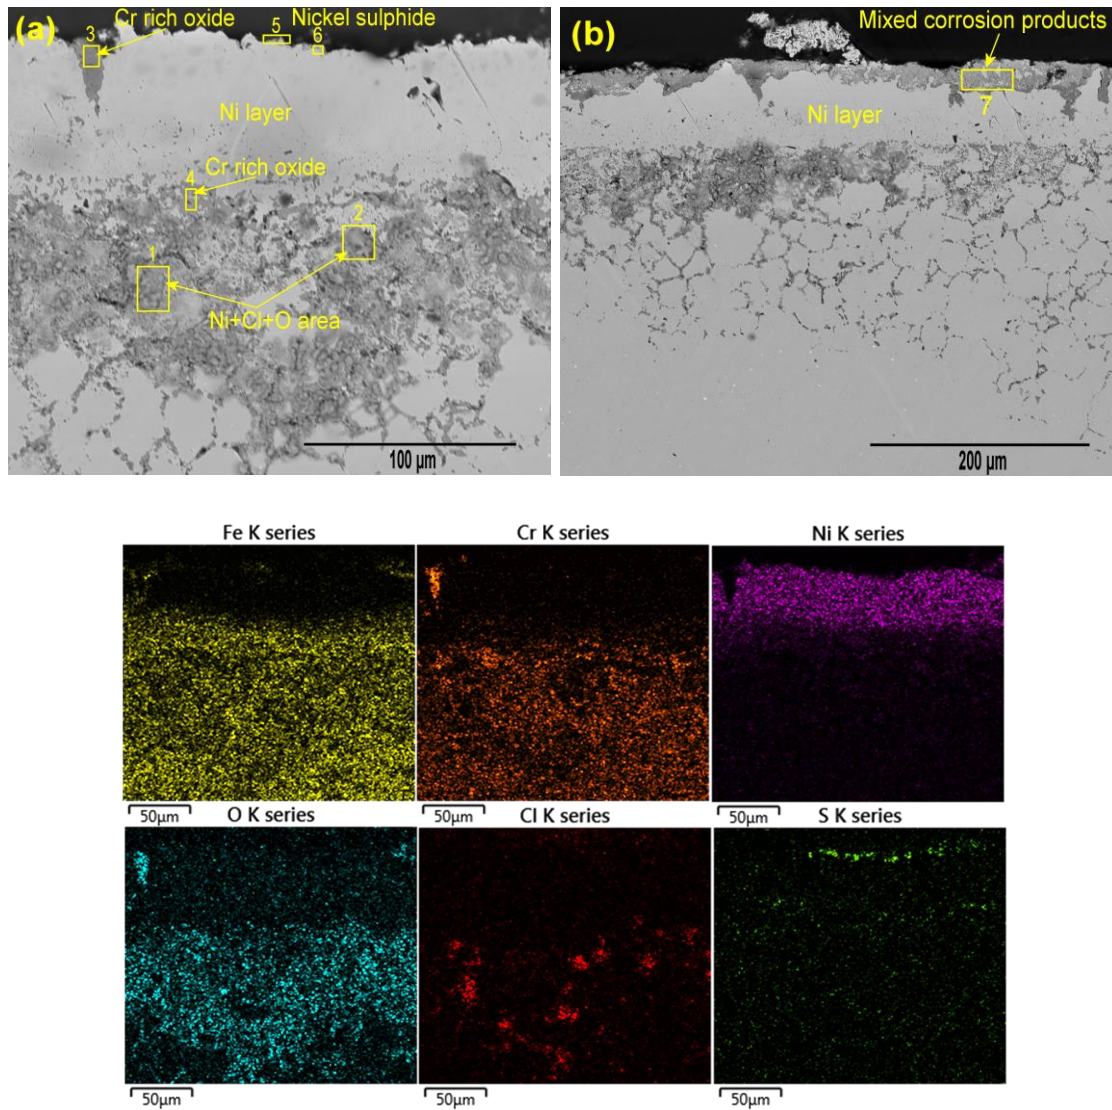
At other locations, where the nickel layer was still present, a large part of the original nickel layer remained with a thickness of about 70  $\mu\text{m}$  (Figure 9a). In some areas, a thick zone of mixed corrosion products could be found above the nickel layer (Figure 9b).

SEM/EDX (Figure 9a and Table 3) show a local area of Cr-rich oxide close to the surface (region 3) and sulphur enrichment in the outer surface (regions 5 and 6) as well as within sulphur rich phases in the nickel layer. The absence of K and Cl on the surface could indicate that the surface corrosion products have been removed during removal and handling of the tubes. Cl enrichment as well as severe grain boundary attack were observed in the underlying TP347H metal. Cl was distributed everywhere where there was grain boundary attack and enriched in localised places (regions 1 and 2).

Figure 9. SEM/BSE of corrosion morphology on the  $\text{Ni}_2\text{Al}_3$  coated tube after boiler exposure for locations with (a) nickel layer and (b) nickel layer with outer corrosion product and EDX chemical element distribution corresponding to (a). Compositions of selected areas in (a) and (b) are shown in Table 3.

elemental composition (wt. %)							
region	Cl	Ni	O	Fe	Cr	Mn	S
1	11.4	13.9	14.6	48.2	10.5	1.4	
2	10.3	16.8	11.0	52.1	9.8		
3			23.7	17.4	58.9		
4			15.8	41.1	43.1		
5		77.9					22.1
6		80.1					19.9
7		49.4	14.1	32.7	3.8

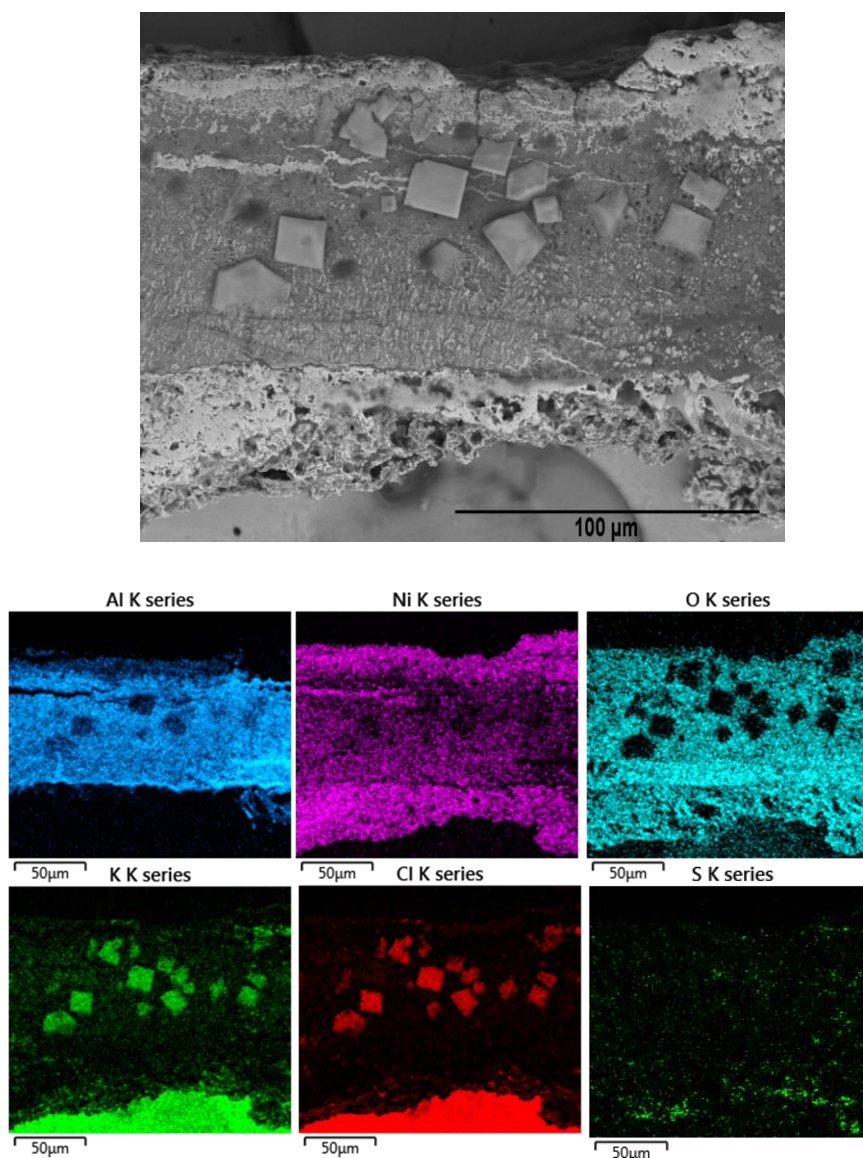
Within the deposit, remnants of the Ni<sub>2</sub>Al<sub>3</sub> coating could be found, and their analysis can give further information as to how the attack progressed on the Ni<sub>2</sub>Al<sub>3</sub> coated tubes. The corrosion morphology and the distribution of chemical elements in the deposit are shown in Figure 10. The top part of the micrograph was closest to the flue gas environment. The coating element aluminium, which was absent at the tube surface locations, was observed in the deposit of Ni<sub>2</sub>Al<sub>3</sub> coated tubes. A multi-layered oxide scale that must have spalled from the tube surface could be found intact in the deposit. The oxide scale had a porous nickel-rich oxide scale at both sides and an aluminium-rich oxide in between. A number of blocky structured potassium chloride particles are dispersed on the top of the multi-layered oxide scale.

Figure 10. Corrosion morphology and element distribution of the deposit on  $\text{Ni}_2\text{Al}_3$  coated tube after boiler exposure.
